Please find enclosed a copy of the Slope Stability Study performed on the area above our Cottonwood Pit. In addition, I have included a map of our permit area.

SUMMARY

An evaluation of the landslide adjacent to the Canyon Cove #2 Subdivision, Salt Lake County, Utah is the subject of this report. The study was authorized and undertaken at the request of Mr. Jay L. Murphy, Wasatch Boulevard and Canyon Cove Company, Salt Lake City, Utah.

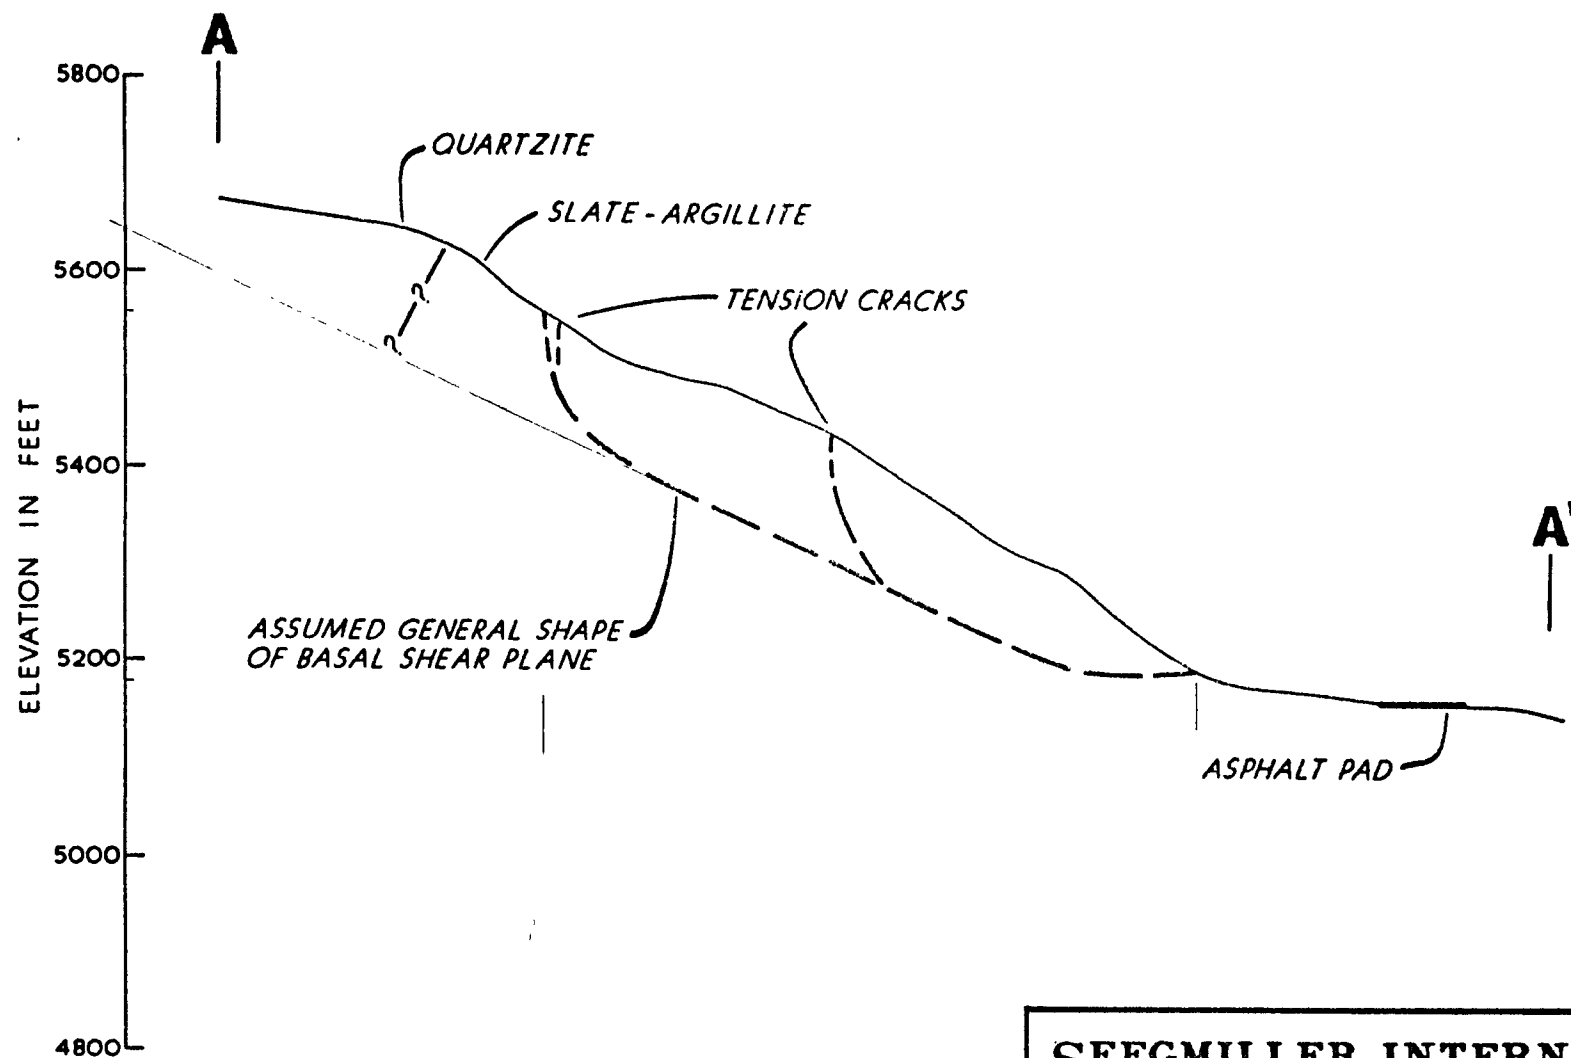
FIGURE 3
LANDSLIDE CROSS-SECTION A-A'

Analysis Results. For purposes of the back-analysis it will be assumed that the cross section shown in Figure 3 is a typical cross section for the landslide. Other assumptions at the time of initial failure in the spring of 1983 include [1] a groundwater condition approximately equivalent to being half-saturated, [2] a material unit weight of 155 pcf and [3] a safety factor of 1.00. Using these assumptions in the Hoek method would allow the relationship of rock mass shear strength in terms of sliding friction angle and cohesion shown in Figure 7 to be constructed. For the Canyon Cove landslide the values of sliding friction angle(ϕ) and cohesion(C), most nearly characteristic of the basal shear plane, are believed to be $\phi = 25^\circ$ and $C = 2700$ psf. These shear strength values may now be used to further investigate the landslide for stability under other groundwater pressurization conditions. A summary of safety factor magnitudes for various groundwater pressurization conditions for the landslide is shown in Figure 8. This figure dramatically illustrates the lessening of the safety factor that may be expected as the groundwater pressurization increases to a point near or at full saturation. The landslide is estimated to have a safety factor of 1.24 under the best conditions when it would be essentially dry. Under the worst conditions of full saturation the safety factor could theoretically drop to as low as 0.87. It should be understood that when the safety factor drops slightly below a value of 1.00, the landslide theoretically begins to move. It will continue to move as long as the pressurization level remains constant. An increase in the pressurization level will cause the landslide to move with increased velocity. Should the pressurization level rapidly increase in a very short time, the landslide could catastrophically fail. If the pressurization level were to dramatically increase to full saturation or nearly full saturation in a matter of hours, the landslide could become fully water mobilized and effectively turn into a mudslide. Such complete saturation may only occur during an intense rainstorm such as during a rainstorm with a probable maximum of ten inches in six hours. Such a probable maximum is the rating¹⁰ by the U. S. Bureau for the Wasatch Front area. The one percent probability six hour rainfall for the Wasatch Front area is 2.5 inches.

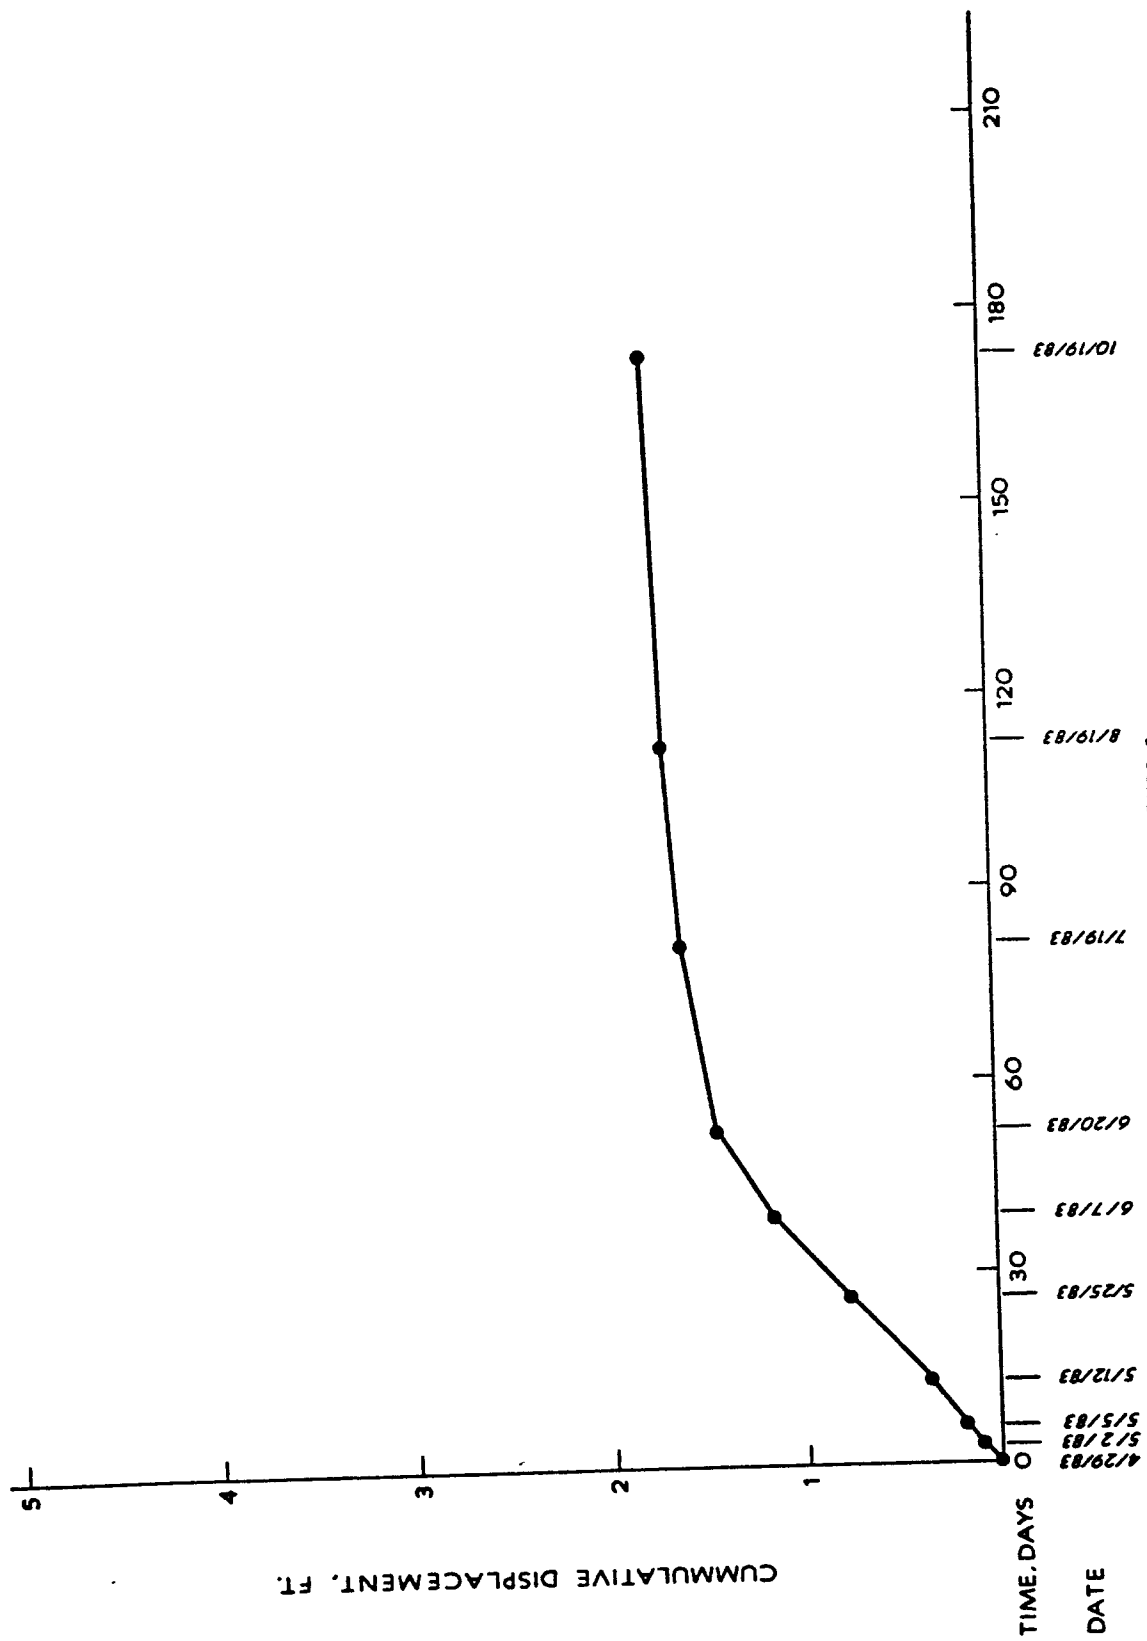
FIGURE 5
CUMMULATIVE DISPLACEMENT VERSUS TIME
CANYON COVE - POINT "B"

the most likely point to first catastrophically displace. Therefore, Point "B" was selected for further displacement analysis. The survey data, when received, consisted of [1] horizontal east-west, [2] horizontal north-south and [3] vertical displacement values. These data were then combined to determine an overall displacement magnitude and displacement vector or direction. The overall displacement magnitude was approximately 1.61 feet for the 173 days during which Salt Lake County performed displacement monitoring. The direction of overall movement was S 74.6° W at an angle of 15.9° below horizontal. The displacement magnitudes serve as a measurement of the stability of a landslide and, as such, they are typically plotted for visual analysis. A common method for plotting the data is to plot cumulative displacement versus time. For Point "B" such a plot is shown in Figure 5. The total cumulative displacement magnitude is 1.77 feet and represents the summation of each individual movement occurring between surveying dates. Owing to the fact that such movements were not each in the overall displacement direction, their summation is 1.77 feet which is greater than the overall absolute displacement from the first survey date to the last survey date of 1.61 feet. In other words the shortest distance between two points is a straight line and that is less than a cumulative distance of many intermediate points, which do not lie on the straight line. The plot shown in Figure 5 indicates that movement of Point "B" has been dramatically lessening since late June 1983 and has shown very little movement from late August 1983 to late October 1983.

Present Status. Based on the displacement data plotted in Figures 5 and 6 and assuming that Point "B" is a representative point for the entire landslide, it would not appear that any adverse movements are occurring as of October 19, 1983. The cumulative displacement has levelled to a degree that indicates continued stability. The velocity has settled down and no erratic

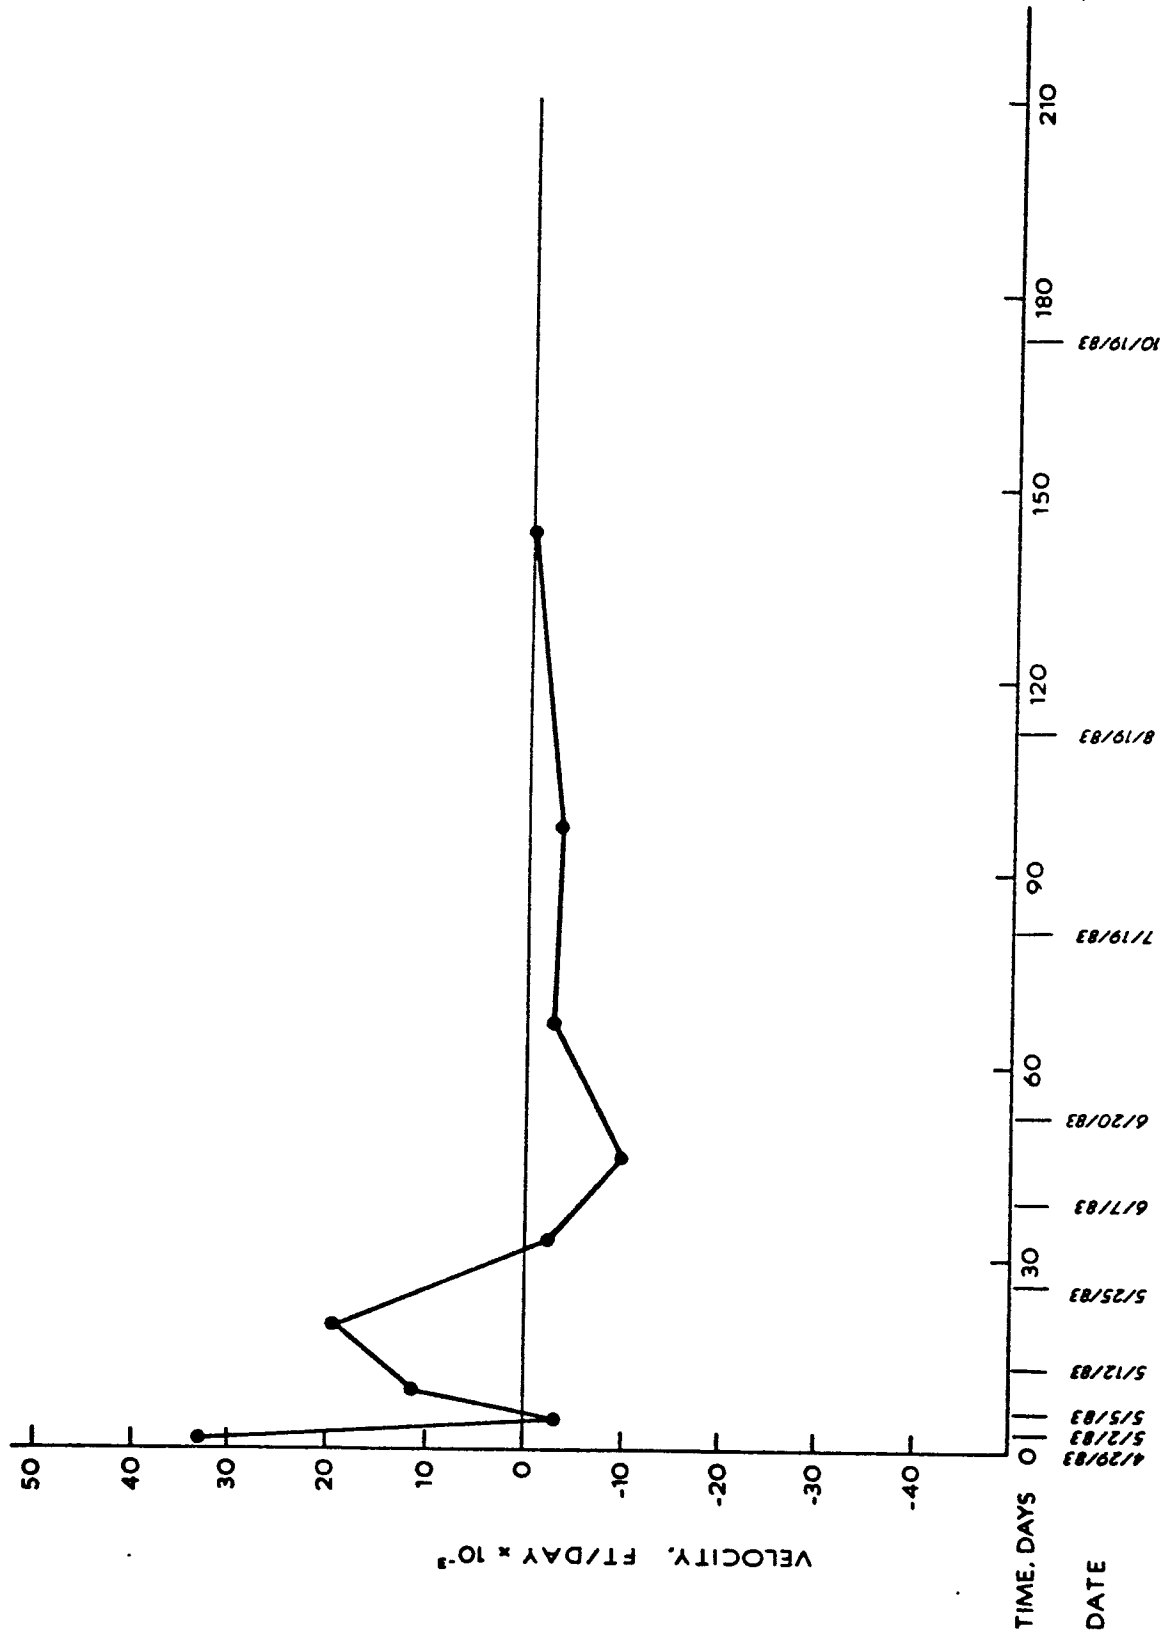
Velocity. Another method of ascertaining the stability of a landslide is to plot velocity versus time and visually assess the results. Such a plot has been made for Point "B" and is presented in Figure 6. As may be noted, the velocity was quite erratic until late June 1983. Since that time, the velocity has generally lessened and was very close to zero during the period August 19 - October 19, 1983.

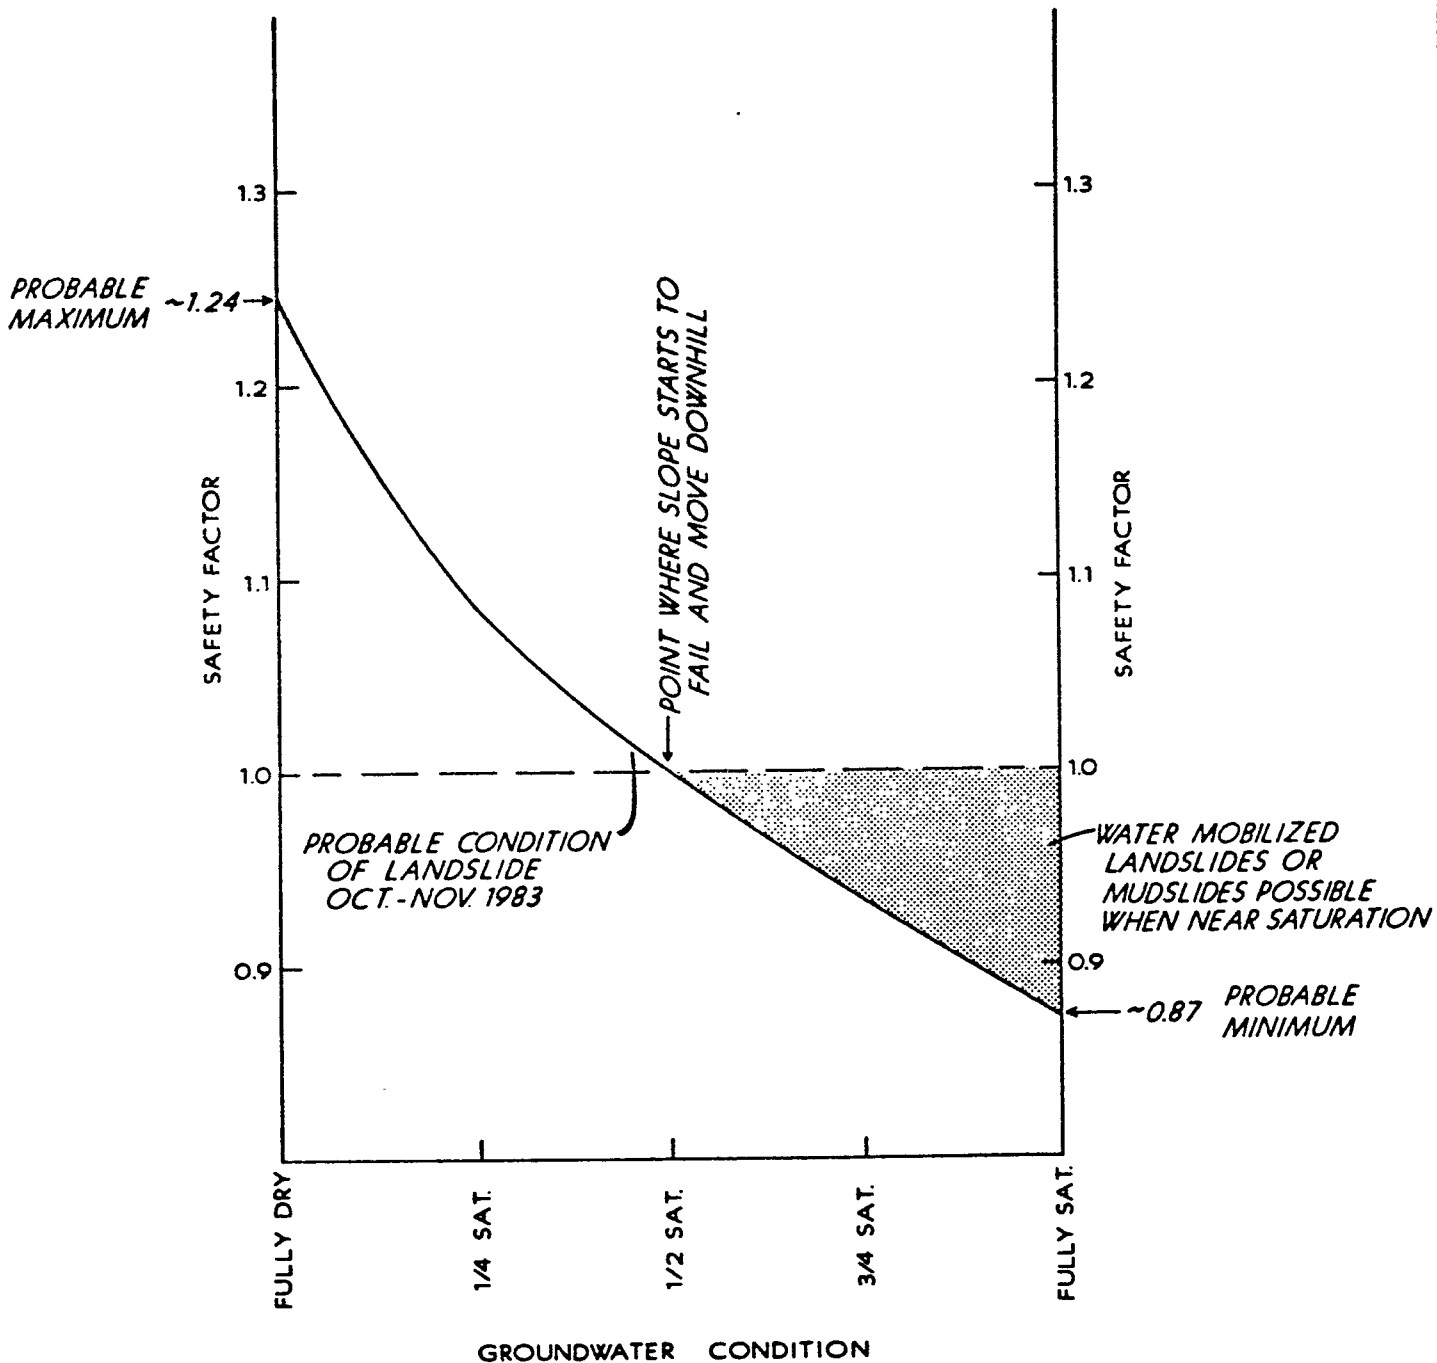
FIGURE 8

ESTIMATED RELATIONSHIP
SAFETY FACTOR AND GROUNDWATER
CANYON COVE LANDSLIDE

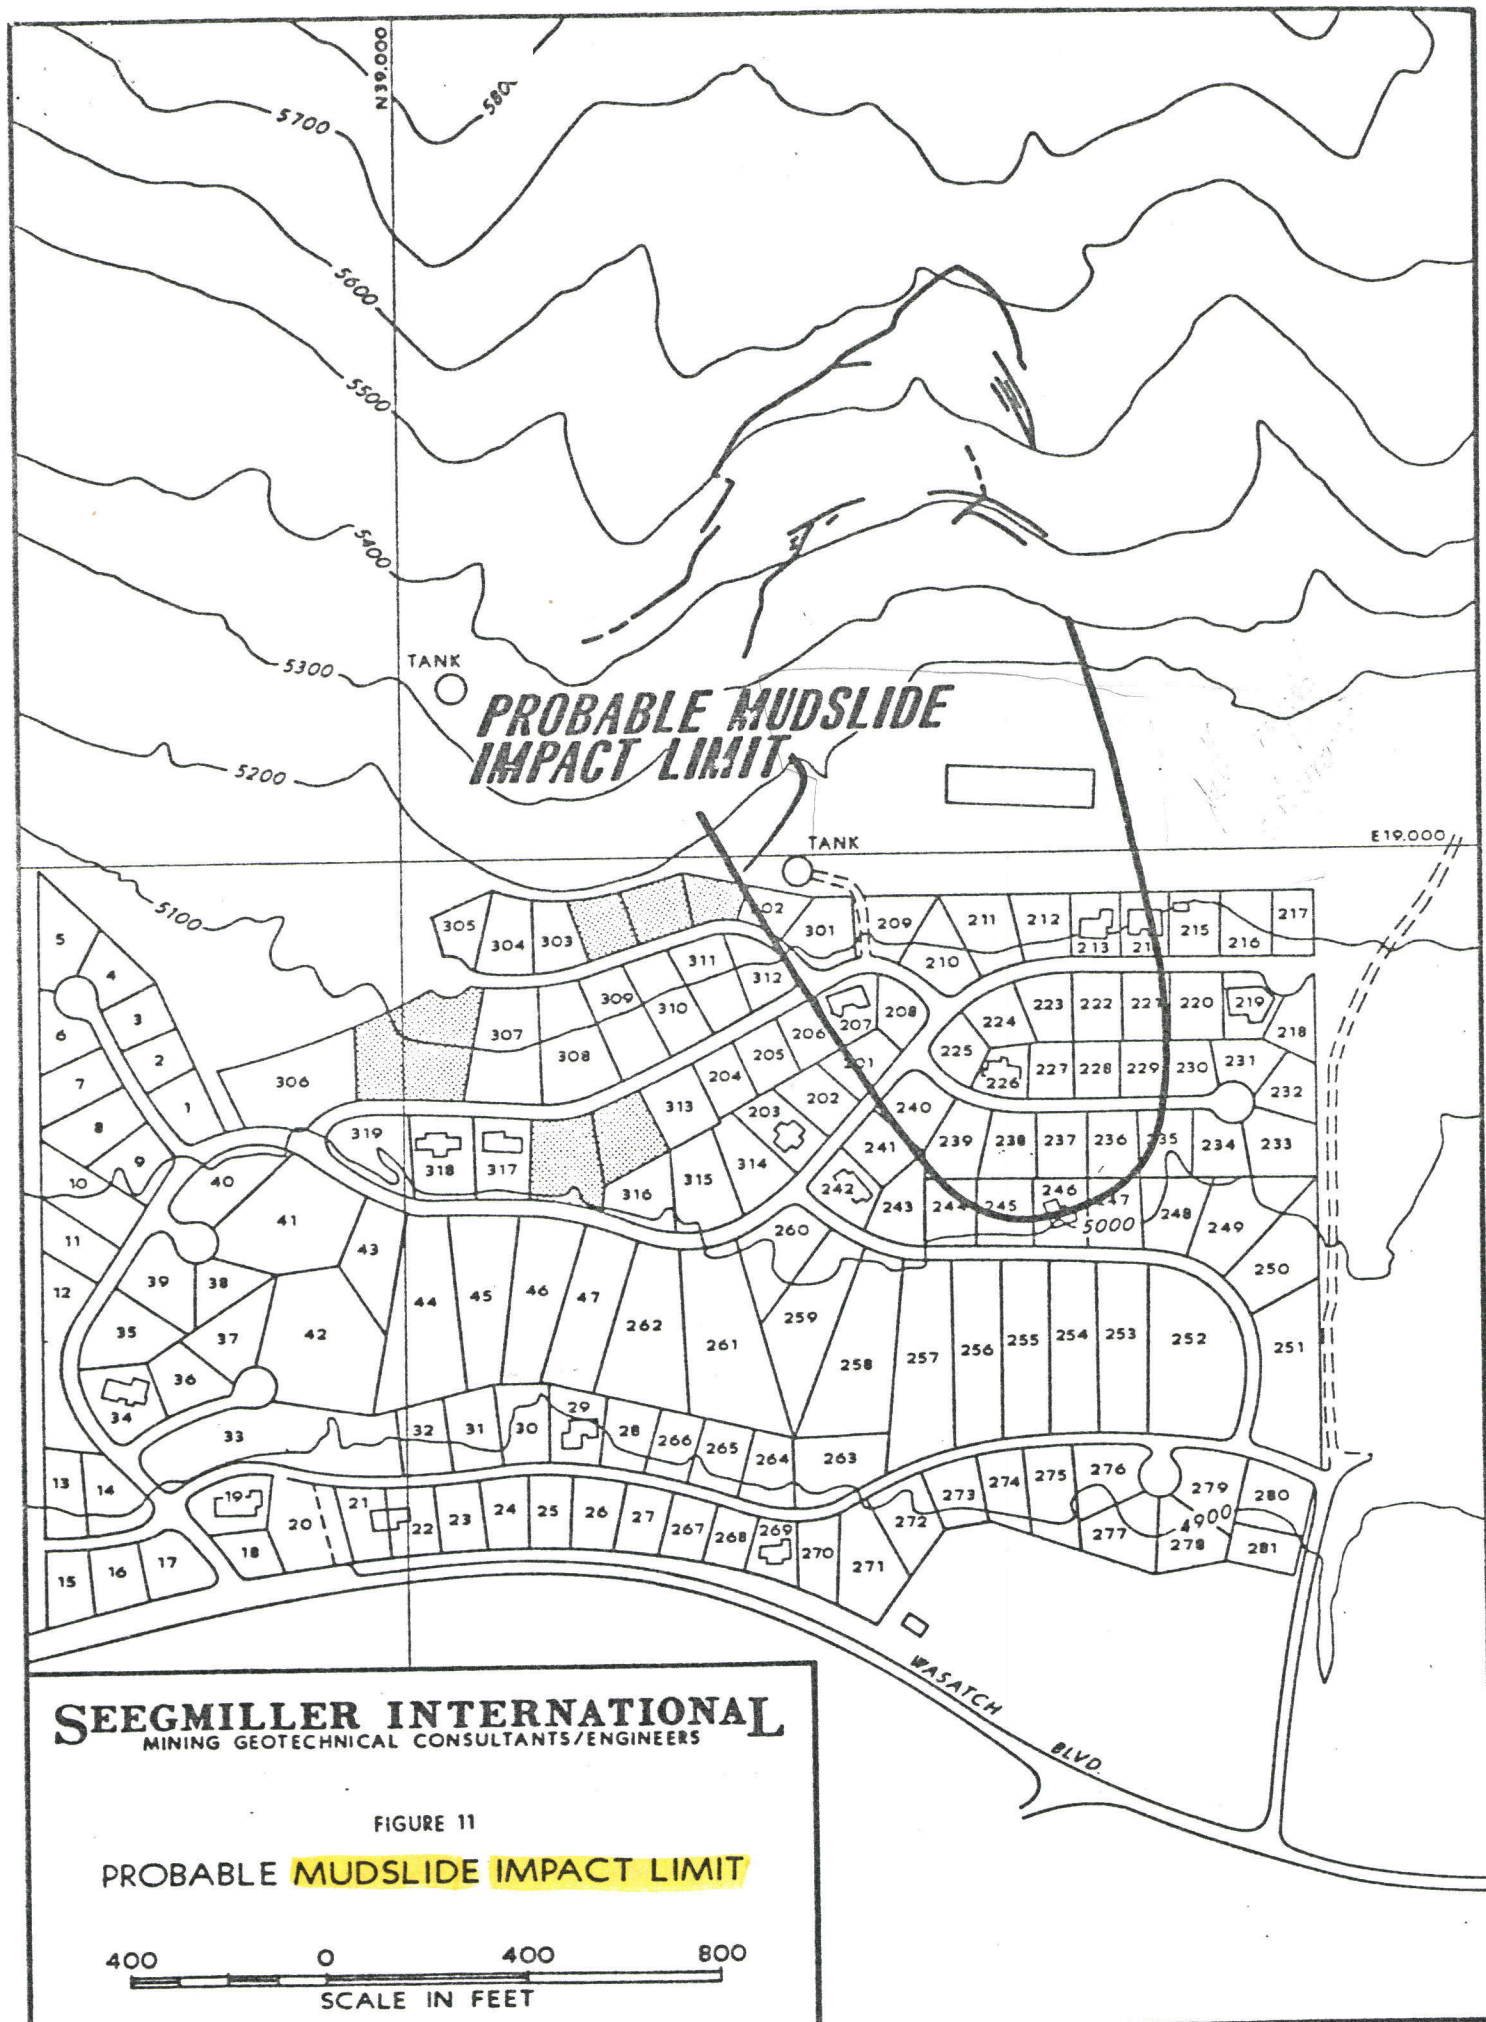
FIGURE 11

Run-Out Analysis: Mudslide. Should the groundwater pressurization increase dramatically in a very short period of time, such as a few hours, the Canyon Cove landslide could become totally water mobilized and fail as a mudflow or mudslide. The criteria for determining the run-out limits has not been well-established by past mudslide documentation. However, an empirical method¹³ which states that the downslope impact area extends a distance equal to the height of the slope for each 5% natural ground slope below the toe, could be used. This criteria was developed for mine waste embankments, and as such, may not be totally applicable to the Canyon Cove landslide. However, such a criteria could give an indication of the worst condition that might prevail if the landslide became a mudslide. Applying the empirical criteria to the Canyon Cove landslide yields the probable impact limit shown in Figure 11. This impact limit may be treated as the most probable limit of the run-out zone given the worst case scenario. The impact on the water storage tank east of lots 301 and 302 can only be estimated. Mudflows tend to move around stiff objects as opposed to pushing them forward. Owing to the fact that the tank is on the north edge of the landslide and the central mudflow impact area, it is not expected to be moved from its foundation. However, as has been previously stated, such events are difficult to predict and caution should be exercised.

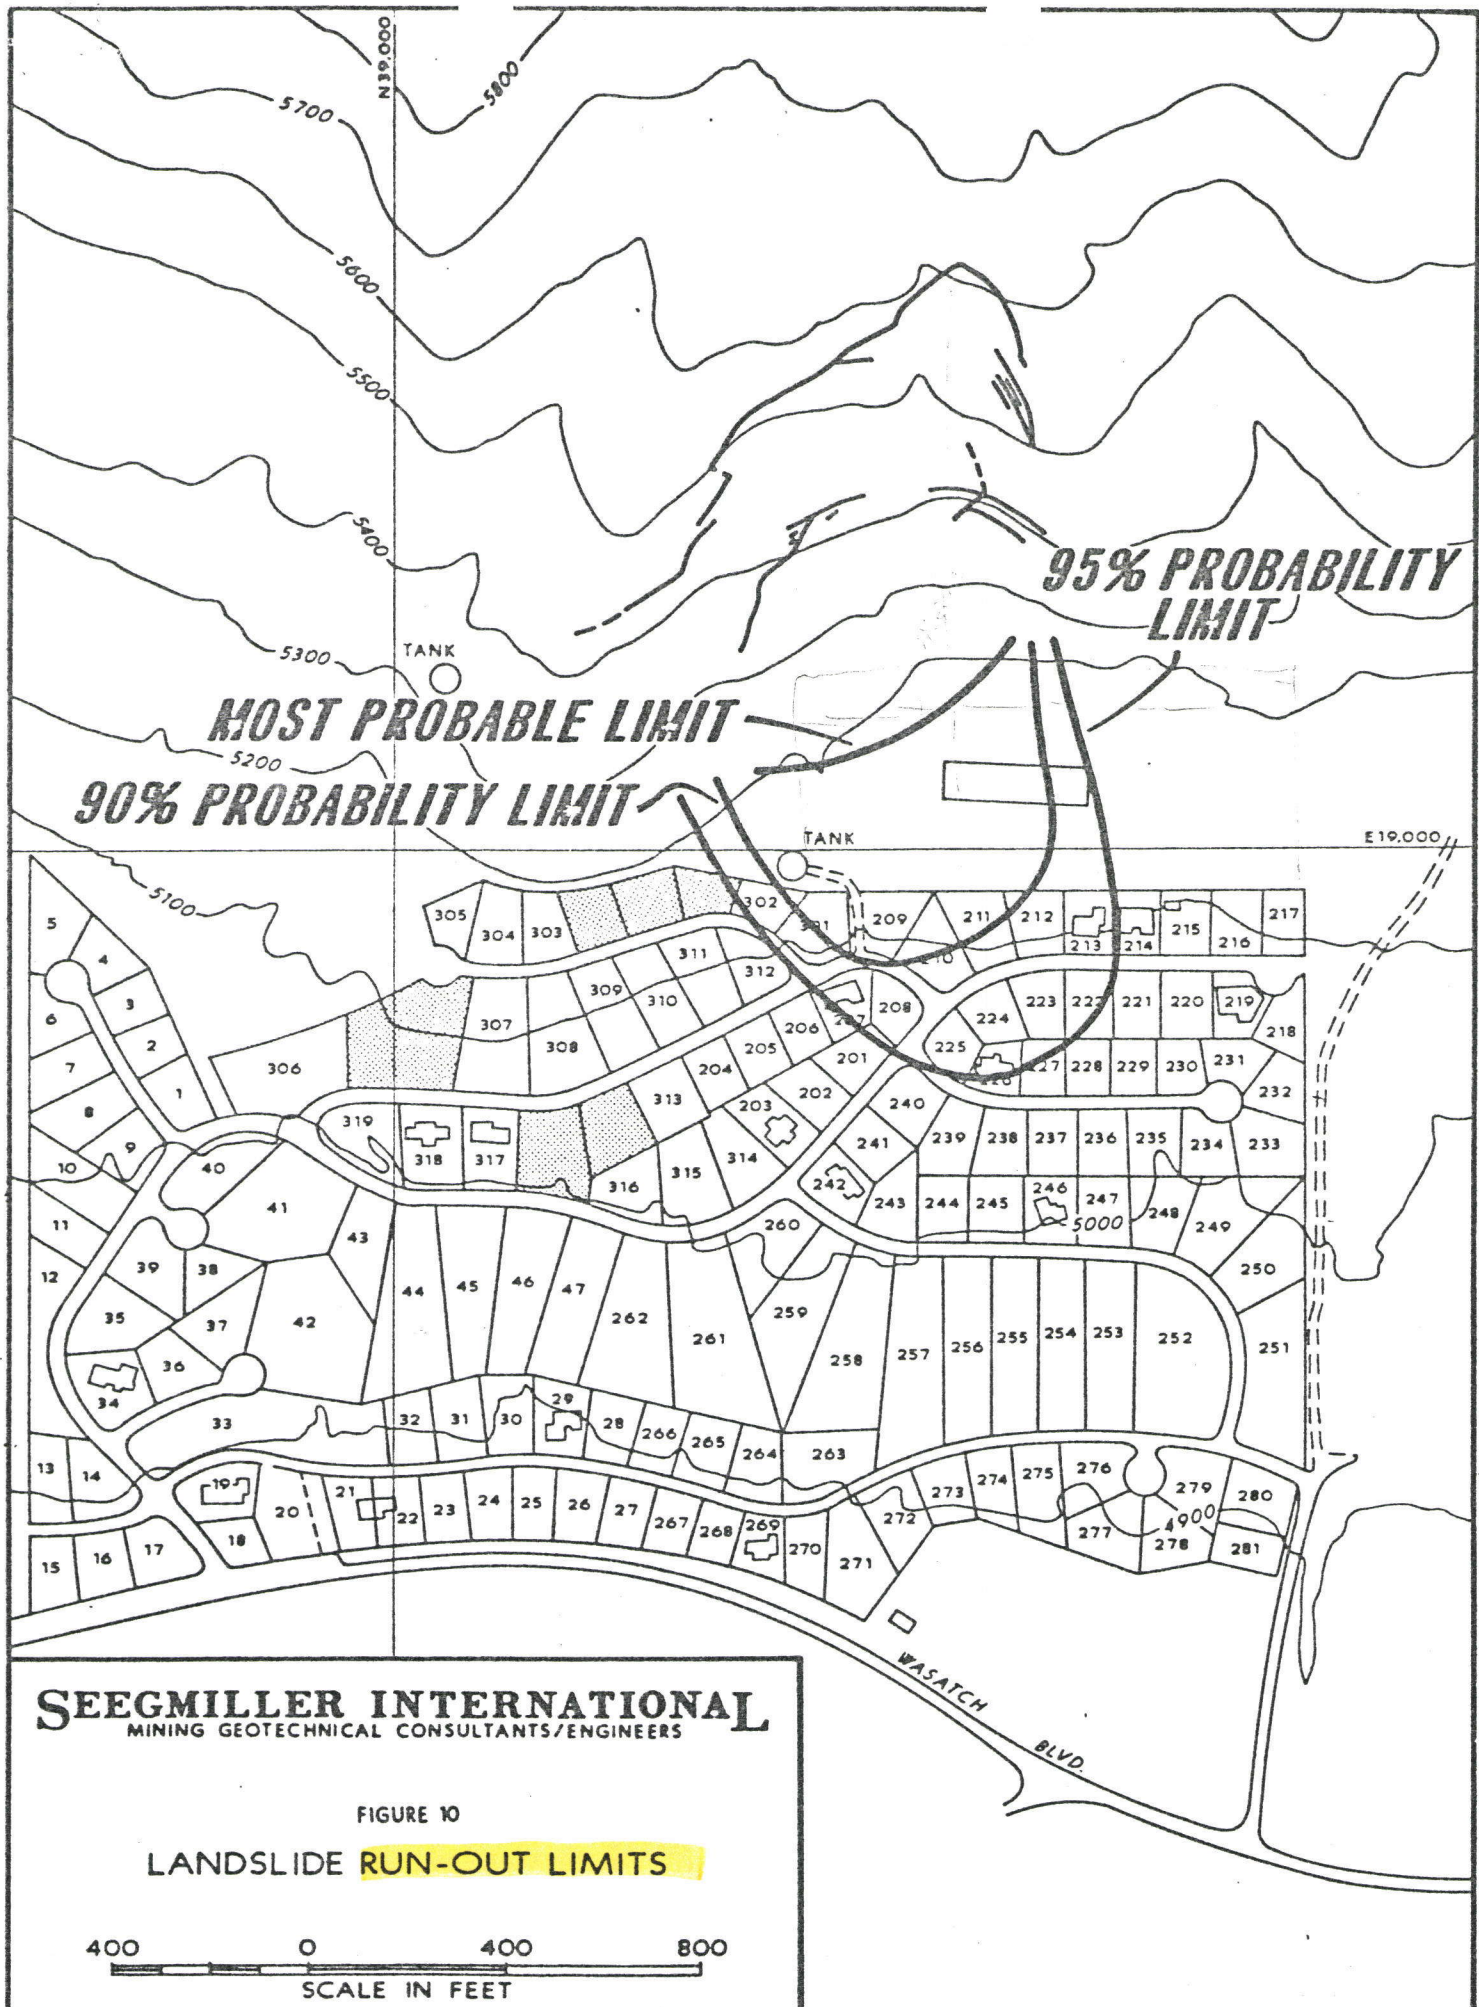
FIGURE 10

conditions and the 90% and 95% probability conditions are shown in Figure 10. If greater probabilities are examined, the limits increase in the general southwest direction. These limits may be taken as the run-out limits for a slide occurring under circumstances similar to those that existed during the spring of 1983. The impact of this event on the water storage tank east of lots 301 and 302 may not be too bad because the tank is toward the side of the main run-out zone. The probability of the run-out area extending to the edge of the tank is estimated to be approximately 20%. However, the forces involved in landslides are known to be large and the exact limits of the run-out zone are not always predictable. Therefore, a cautious approach is recommended.
